Home Inspection Report

Report Number: 108-160 For The Property Located On:

2419 Olivet Church Rd Winston-Salem, North Carolina 27106

Date of Inspection: Friday, July 17, 2015

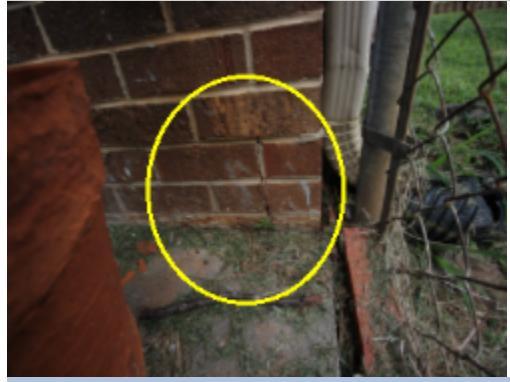
(A1 - 1.1) Main House

Cracks were noted at the right rear corner in the brick veneer. Cracks in brick veneer indicate a deficiency that can change or progress over the life of the home. The cracks on this home at the time of the inspection presented no visible evidence of progression to the foundation areas. The buyer should observe the cracks and assess their concerns related to the presence of the cracks, the number of cracks, and possibility of the condition worsening over the life of the home. If the buyer has additional concerns an engineer should be consulted to determine the significance of the cracking.

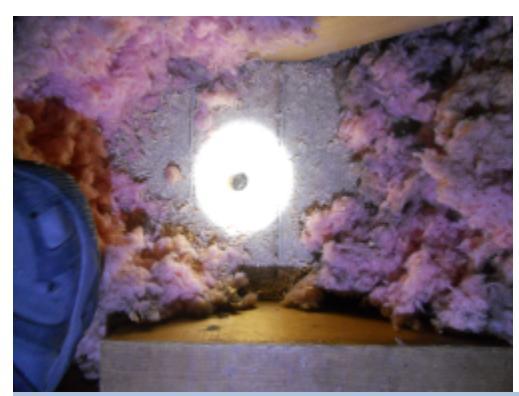
Holes like this in the attic along the ceiling structural members may be indicate a history of termite extermination/inspection. Termite infestation/problems should be disclosed by the seller. I did not see any other signs of pest infiltration, however I am not a licensed pest exterminator/inspector. pest inspections is beyond the scope of a home inspector. A licensed exterminator should be consulted if you choose to further investigate this matter.

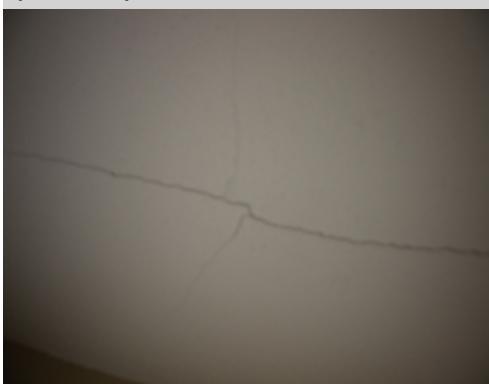
(A5 - 1.1) All Accessible Interior Areas

The ceiling in the hallway is cracked. No related concerns were noted in the throughout the other inspection areas. The buyer should review the area of concern. If additional concerns or questions are present, invasive inspection and repair will be needed. Ms. Saunders, while inspecting the attic, I lost my footing. Even though I did not fall through the ceiling, unfortunately I did cause this crack to appear. I will repair/replace this section of ceiling.

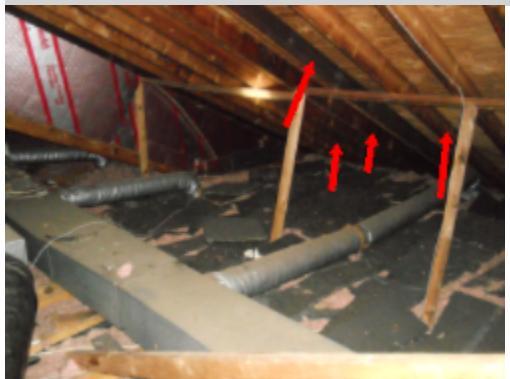
(A6 - 1.1) Main House

Evidence suggests that this home has been subjected to a fire. In the attic area, the framing was noted to be black/charred. Construction restoration after a fire must include all systems. In most cases all electrical, plumbing and insulation components are replaced. Any charred wood members that are not replaced require sealants to prevent reoccurring odors and engineering review and letters of structural integrity to remain with the home. The home owners should be asked for disclosure related to the extent of the fire and details for the renovation. An engineer should be consulted for a complete evaluation of the home and all the systems.

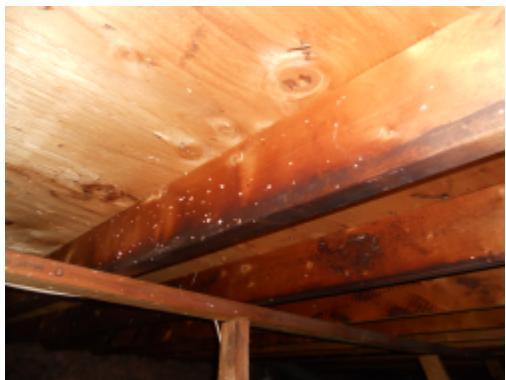
(A6 - 1.2) Main House

Additional Photograph: This is a photograph of another section of roof rafters showing evidence of fire damage.

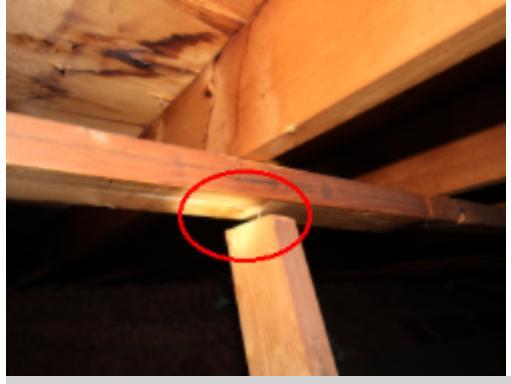
(A6 - 1.3) Main House

From the attic of the home, the purlin support beams are not installed with proper cuts to provide a full contact bearing to the purlin board. When the purlin board and support beams do not have full depth contact, the rafter can move, crack, or split over time. A licensed general contractor should be consulted for further evaluation and to make necessary repairs.

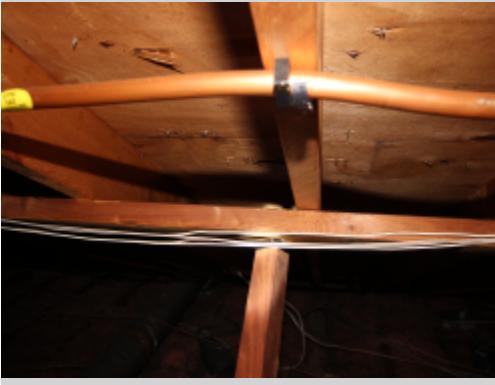
(A6 - 1.4) Main House

Additional Photograph: This is a photograph of an additional purlin member that has not been properly fastened as stated in the summary, a licensed contractor should be consulted for repair/replace.

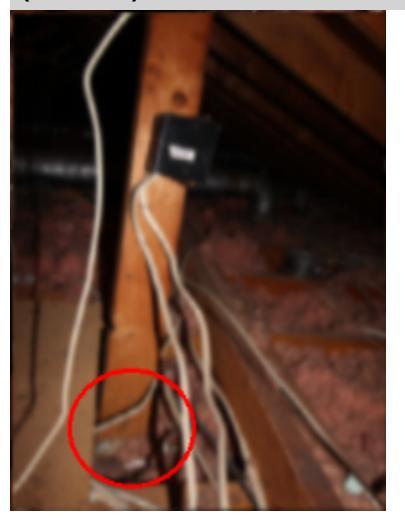
(A6 - 1.5) Main House

The roof framing has been modified, the area of concern was located in the attic concerning the vertical supports for the rafters/purlins. The footing for these supports are not connected to a wall structure or another vertical support therefore heavy loads on the roof (ice) could cause damage to the roof/ceiling structure. The framing modifications do not follow standard framing methods that would normal be observed for a framing repair. The owners should be asked for disclosure related to the extent and history of repairs and if all required building permits were obtained. A licensed general contractor should be consulted for a Complete evaluation of the ceiling/ attic floor/ roof system to determine the extent of the concern and to make necessary repairs to ensure the stability and durability of the attic/floor/roof system.

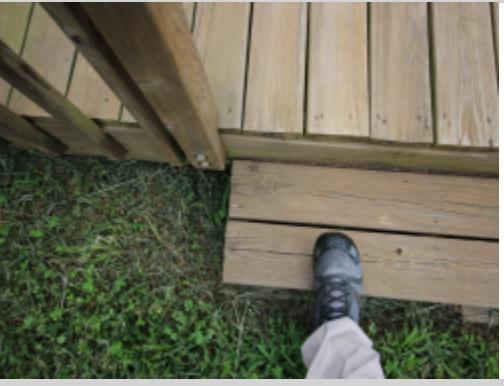
(B3 - 1.1) Deck

The wood steps for the detached deck are in need of repair. The steps should be repaired to ensure safe entry and egress for the home. The following concerns were noted at the time of the inspection: Steps felt loose to the foot when light pressure was applied. A licensed general contractor should be consulted for a complete evaluation and to make necessary repairs.

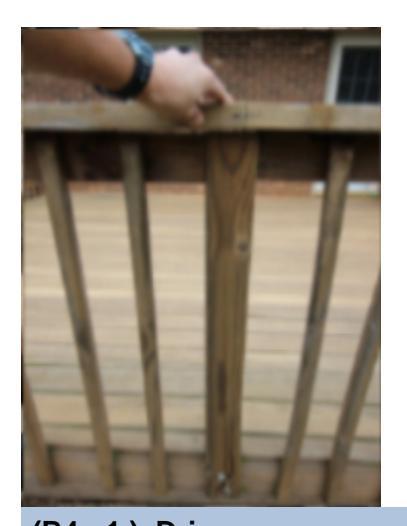
(B3 - 1.2) Deck

The handrails to the detached deck are loose and present a safety/fall hazard. A licensed general contractor should be consulted for evaluation of the deck handrail system and to make necessary repairs.

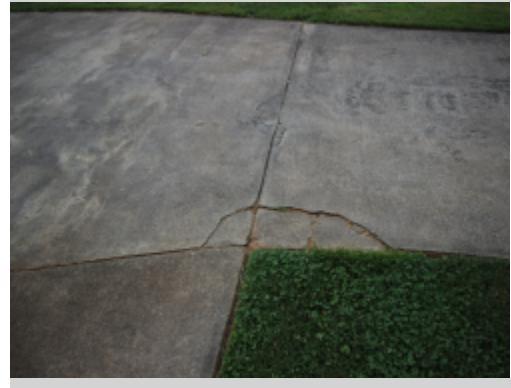
(B4 - 1.1) Driveway

The driveway is cracked and displaced. The raised section of the driveway has created a path for water penetration under the slab and a trip or fall hazard. A licensed general contractor should be consulted for further evaluation and repair.

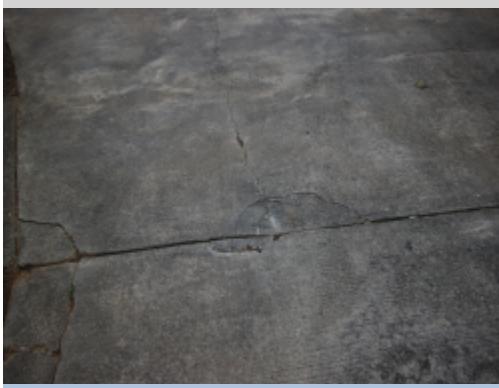
(B4 - 1.2) Driveway

Additional Photograph: This is a photograph of more cracks/displacement in the concrete of the driveway.

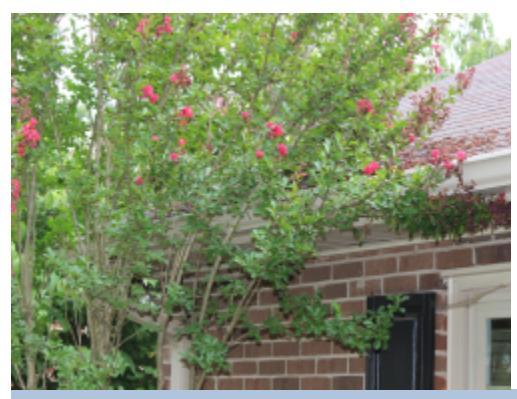
The vegetation around the perimeter of the home is over grown and blocks the air circulation around the home. The growth also limited the inspection access. Damage from over grown vegetation can occur to the homes foundation, outer shell and gutter/roof components. A landscaping company should be consulted to correct the over growth and the inspection should be completed prior to purchase.

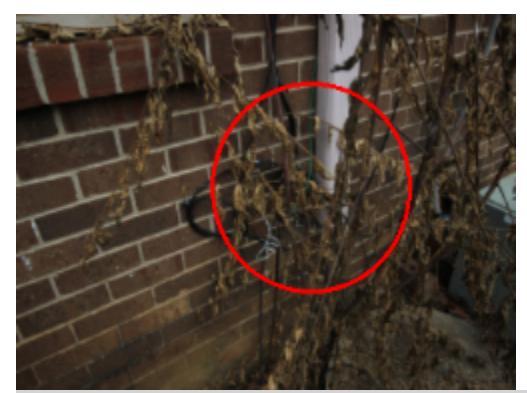
The gutter downspouts are not extended or piped to direct roof drainage away from the foundation. Direct drainage from the gutter system can result in direct water penetration into the foundation area and foundation deterioration. A licensed general contractor should be consulted for a complete evaluation and to make necessary repairs.

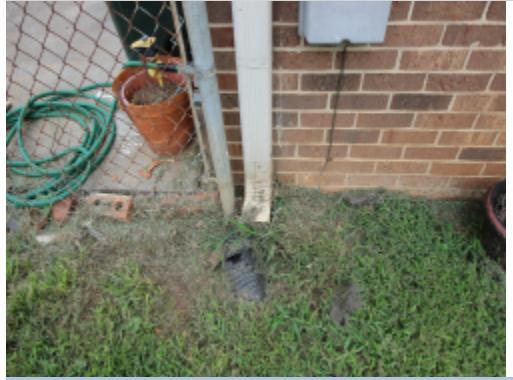
(C2 - 1.2) Main House

The gutter downspout at the rear right corner is clogged. Evidence on the bedding areas indicates that the gutters have been overflowing. Direct drainage from the gutter system can result in water penetration into the foundation area and foundation deterioration. A licensed general contractor should be consulted for a complete evaluation and to make necessary repairs.

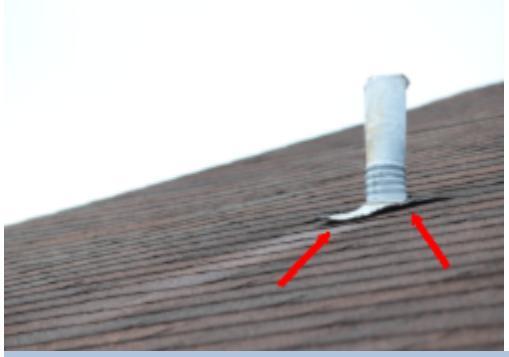
(C3 - 1.1) Main House

The plumbing vent boot located on the rear side of the roof was installed over the shingles and not lapped under the roof covering to shed water down the roof surface. This installation relies on caulking and will result in leaks. A licensed roofing contractor should be consulted for evaluation and repair to ensure the weather-tightness of the roof covering system.

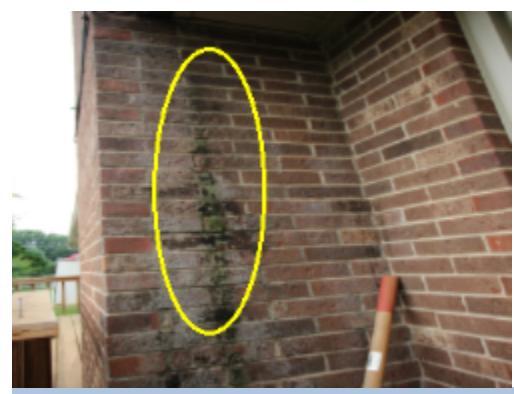
Efflorescence (salt stains) was noted on the chimney. This type of staining serves as a warning, indicating that water has found a point of entry between the brick body and the flue liner or framing. Water penetration issues need to be addressed to prevent damage to the chimney and adjacent wood framing members. A general contractor should be consulted for a complete evaluation to determine the source of the moisture, possibility of hidden damage, and to make necessary repairs.

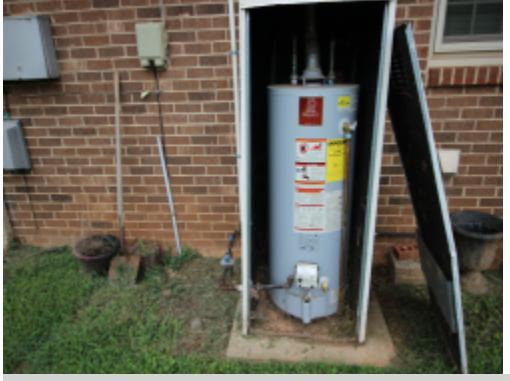
(D3 - 1.1) Unit #1

The 4 year old hot water heating unit for this home is located in a metal hut located on the exterior of the home. The hut is not secure and is leaning/loose. The hut needs to be level and secure to provide a safe and secure container for the water heating unit. Leaving an expensive unit in this condition gives opportunity for thieves to take the precious metal (Copper) and/or the unit itself. A licensed plumbing contractor should be consulted to evaluate the system and repair/ replace as needed to ensure safe and reliable hot water supply.

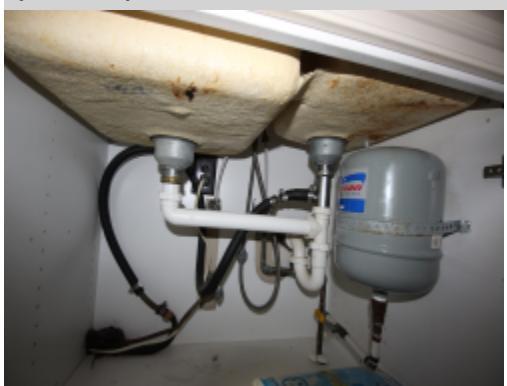
(D3 - 1.2) Unit #1

The heat expansion tank for the gas water heater is located under the kitchen sink. Typically these are positioned higher than the water heater unit itself. Heated/hot water expands and needs a place to go if the unit is at capacity. Heated water like heated air wants to rise. A path that leads hot water downward could result in poor performance of the expansion tank and/or the water heater as well. A licensed plumbing contractor should be consulted to evaluate the system and repair/ replace as needed to ensure safe and reliable hot water supply.

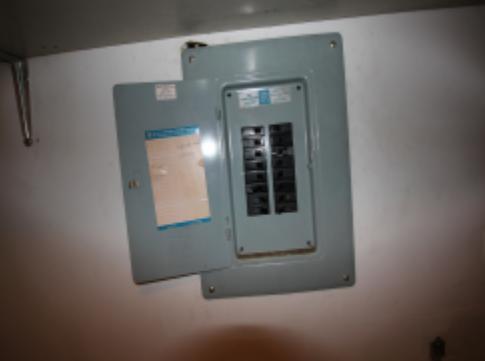
way to quickly turn the power off in case of an emergency. Typically any system that requires more than six hand movements to shut down all system is considered unsafe. A licensed electrical contractor should be consulted for repair and a complete evaluation of the electrical system.

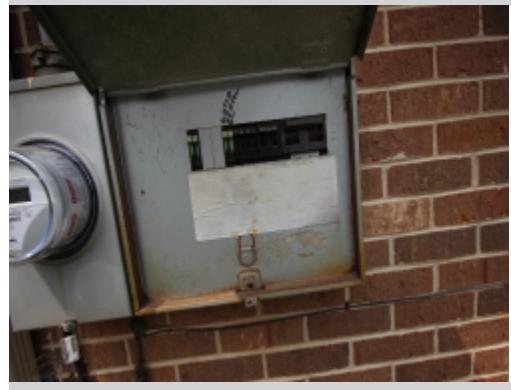
(E3 - 1.1) Distribution Panel #1

The electrical service panel is not secure where it is attached to the wall of the home. This condition presents a safety hazard that could result in serious personal injury and or property damage. This panel serves as your water heater breaker. Spots of rust were also noted to exist inside the panel. apparently moisture is making its way inside the panel. The electrical panel cover was not removed and the inspection was not completed. A licensed electrical contractor should be consulted for a complete inspection of the electrical system and for repair/replacement of the panel to ensure that it is safe and functioning properly.

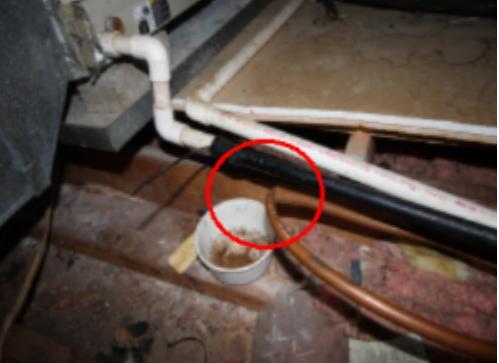
(F1 - 1.1) Heating Unit #1

This home has copper gas lines. This gas line has specific installation requirements related to required bending allowances, support, protection, and electrical bonding to ensure safe conditions. A section of the copper gas line located in the attic is installed with a sharp radius bend (kink) that is not typical for this pipe size. Improper installation could result in leaking and hazardous

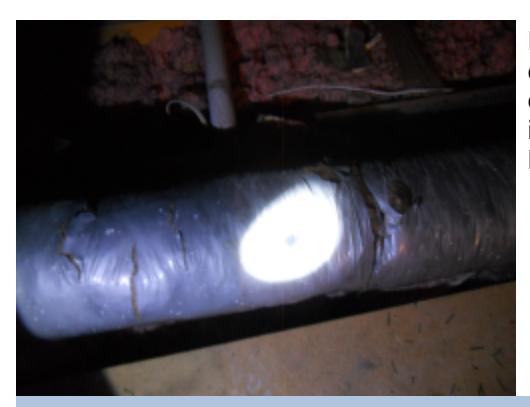
Even though there was no measurement of leaking air from the air ducts, visible wear/deterioration is present on a large part of the air ducts. It is wise to keep an eye on the progression of deterioration. It is even wiser to have an annual home inspection from Solid Ground Home Inspections.

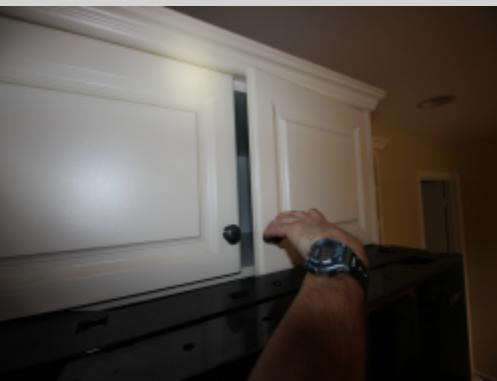
(H2 - 1.1) Kitchen

There was not enough clearance between the upper cabinets above the refrigerator and the refrigerator to open the cabinet door. The refrigerator may be too tall for this location. This could be an adjustment issue or consider taller cabinets or shorter refrigerator should you decide to utilize this cabinet space.

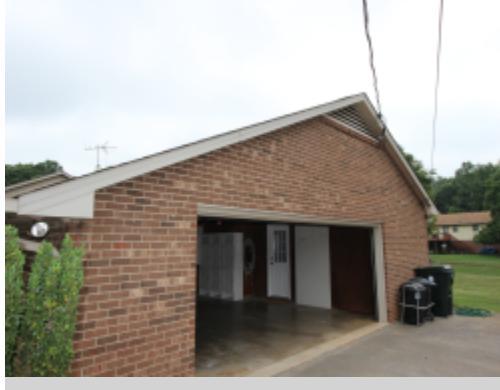
(H4 - 1.1) Garage

The garage door needs adjustment and repair. The door did not stop/reverse when the path was interrupted with reasonable force. A garage door installation company or a licensed general contractor should be consulted for evaluation and repair to ensure that the door operates safely and properly.

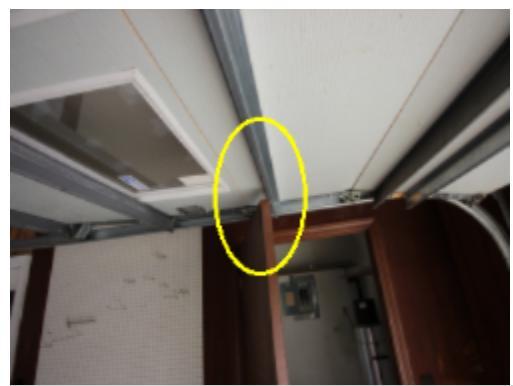
(H4 - 1.2) Garage

Clearance between the rear and front storage room doors to the garage door is obstructed by the garage door impeding use of the storage room door. Damage to the garage door or both storage room doors could occur if storage room door(s) is/are left opened when lifting/lowering the garage door. All systems listed should be evaluated and repaired as needed by a general contractor to ensure that all systems are functioning as intended. The contractor should consult specialist in each trade as needed.

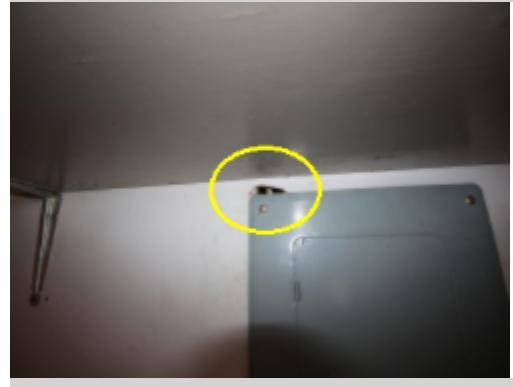
(H4 - 1.3) Garage

The wall in the storage room at the main panel has a hole in it. No related concerns were noted. Holes in any wall can lead to the infiltration of unwanted pests and loss of heat/cooling. The buyer should review the area of concern. If additional concerns or questions are present, invasive inspection and repair will be needed. All systems listed should be evaluated and repaired as needed by a general contractor to ensure that all systems are functioning as intended. The contractor should consult specialist in each trade as needed.

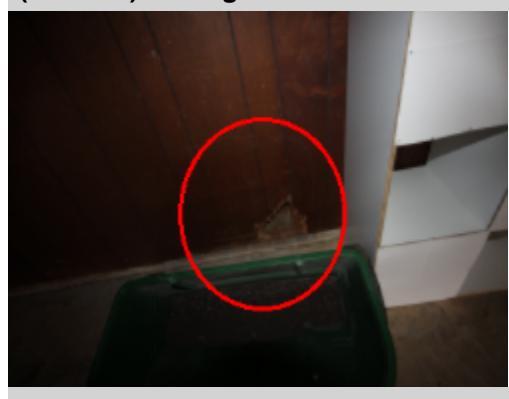
(H4 - 1.4) Garage

Additional Photograph: This is a photograph of another hole in the wall located in the garage. Holes in walls allow the escape of warmth/cooling and the infiltration of pest/rodents.

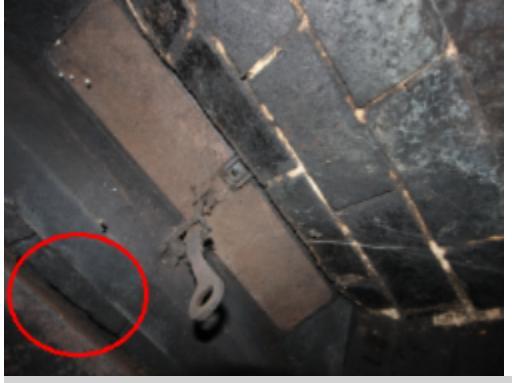
(H6 - 1.1) Fireplace: Masonry

From the fireplace opening, it was noted that the bricks in the chimney throat was loose and/or deteriorated. Also the dampener is a bit rusty. Deterioration of the chimney throat can result in improper draft and operation of the fireplace. A chimney sweep and general contractors should be consulted for a complete evaluation of the chimney is safe and functional.

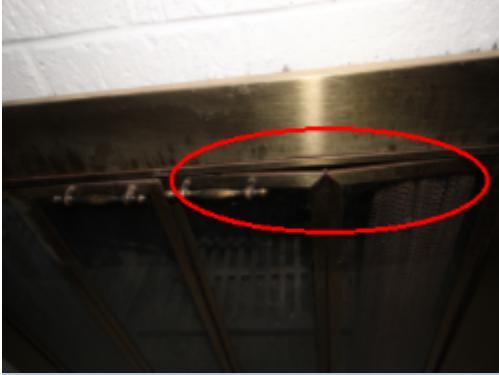
(H6 - 1.2) Fireplace: Masonry

The screen/door to the fireplace does not operate smoothly as it should. It is relatively difficult to close properly. Screens provide a "safety net" to impede hot ash/sparks and smoke from escaping the fire box. Although it is possible to close it, which keeps this from appearing in the summary, a licensed general contractor should be consulted to repair/replace or to direct a specialist in this field to evaluate and execute their next move.

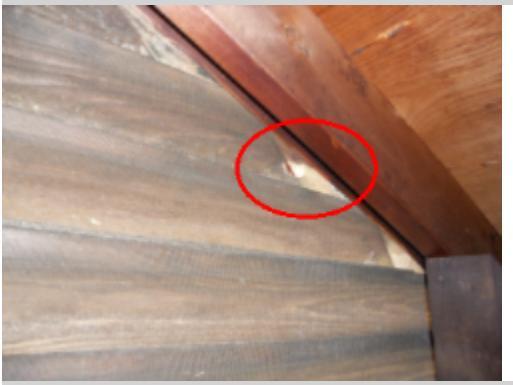
(I1 - 1.1) Attic

The screen which detours pests located at the Gabel vents in the attic have holes in them. This would be a mechanical defect, thus can result into pest infiltration. Screens are not warranted nor have a guarantee that I know of. Pests can cause serious structural damage provide an un-sanitary living environment. A licensed general contractor should be consulted to ensure that systems and component are functioning as intended. The contractor should consult specialist in each trade as needed.

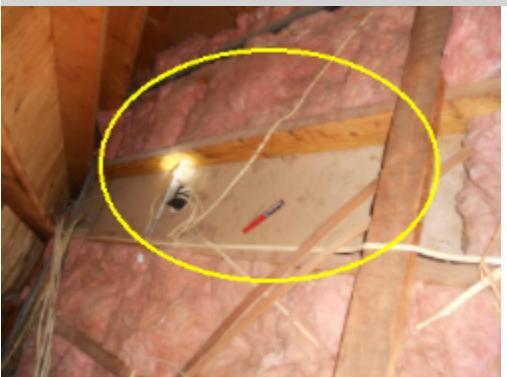
(I1 - 1.2) Attic

A section of insulation in the attic is missing. Improper insulation installation could result in condensation, over heating of the building components, and inadequate conditioning of the living areas. A licensed general contractor should be consulted for repair/ replacement.

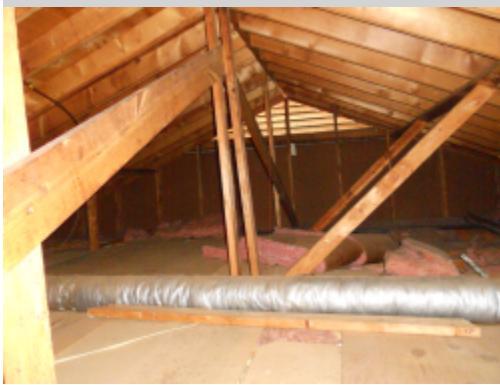
(I1 - 1.3) Attic

Ms. Saunders, This house had a ridge vent at one time. There is now a ridge board roof system using the gable vents as the prime ventilation system for the attic. It appears to be ventilating, however, the speed in which the attic ventilates will determine how efficiently your home cools itself. The quicker you remove the hot, moist air out of the attic will, in turn, allow the hot, moist air inside your home, at the ceiling to escape into the attic, thus resulting in lower energy to cool the home. Installing an "attic fan" will help with this process. FYI: Even with a ridge vent, having a simple "desk" oscillating fan on low, in the attic, will help with cooling costs of the home. You will want a gable vent fan for this home. Using an oscillating fan can blow moisture back to your attic support members. Moisture control starts at the foundation. Moisture from the ground travels through the foundation, up the wooden house framing into the attic framing then out into the attic air. Removing the hot air out of the attic will help control cooling costs and moisture levels.

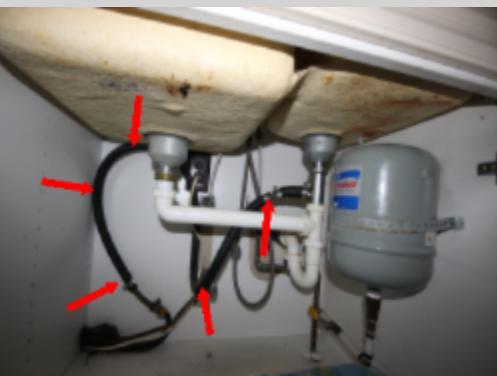
(J1 - 1.1) Dishwasher

The drainage pipe from the dishwasher to the sink plumbing was not installed in manner to prevent sewer from backing up in the event of a plumbing clog, (high loop). The dishwasher needs further evaluation and repair to ensure sanitary and proper operation. An appliance repair person should be consulted.

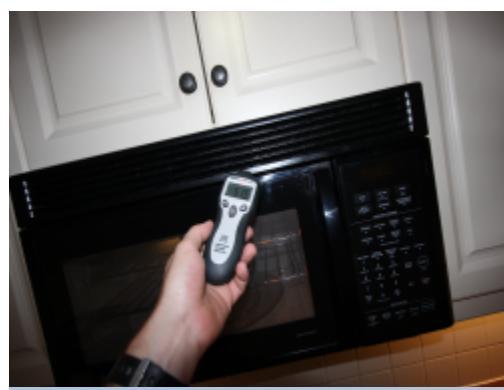
All microwave ovens seem to leak radiation around the doors. This one had a rather higher reading at the top of the door. Leakage readings were measured for about 3.5 to 4 feet away from the microwave oven until it measured 0.0 This leakage detection is beyond the scope of a home inspector. I do not have any information about this microwave oven or any advice as to which ones to use, or advice as to how to mitigate the leakage. This test was courtesy from Solid Ground Home Inspections, inc. I want you to know your home.

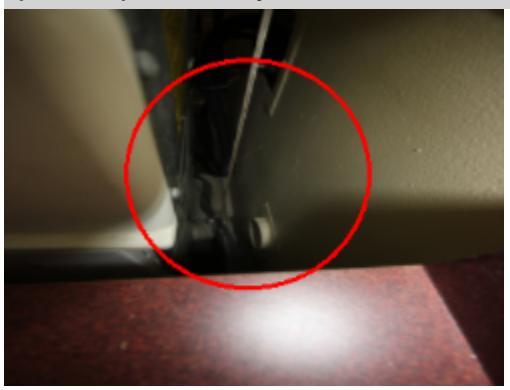
(J1 - 4.1) Vent: Dryer

The dryer duct for this home is a flexible plastic duct, and is disconnected. Most new dryers require a metal duct. A HVAC contractor should be requested to upgrade this duct for safest operation.
