Home Inspection Report

Report Number: 108-160 For The Property Located On:

2419 Olivet Church Rd Winston-Salem, North Carolina 27106

Date of Inspection: Friday, July 17, 2015

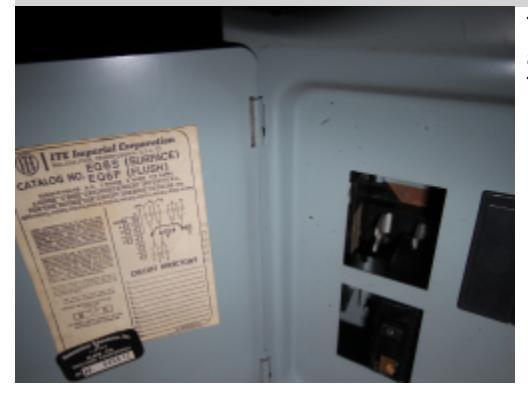
(E3 - 1.2) Distribution Panel #1

This is a photo for the breaker located inn the attic that operates the air handler which is also located in the attic. It is a 15 amp breaker. This is on the report so you know where it is located.

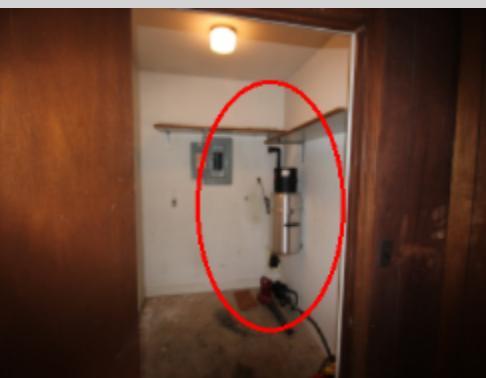
(H4 - 1.5) Garage

This is a hard wired vacuum system. This system is beyond the scope of a home inspector. Contact a general contractor or Home vacuum system dealer for further information/evaluation and testing.
